BIOMEDICAL RESEARCH AND ANALYSIS

October 2, 2015

Additional information was supplied to Biomedical Research & Analysis for review after the preparation of the original report. The additional information consisted of one photograph of the water loaded tractor-trailer at the scene of the impact, one photograph of the cement loaded tractor-trailer at the scene of the impact and one photograph of the cement loaded tractor-trailer after the time of the impact. These photographs provided a greater overall depiction of the water loaded tractor-trailer and the cement loaded tractor-trailer at the scene of the impact. Due to these additional photographs, measurements of the damage to the vehicles were able to be obtained and additional analyses were able to be performed.

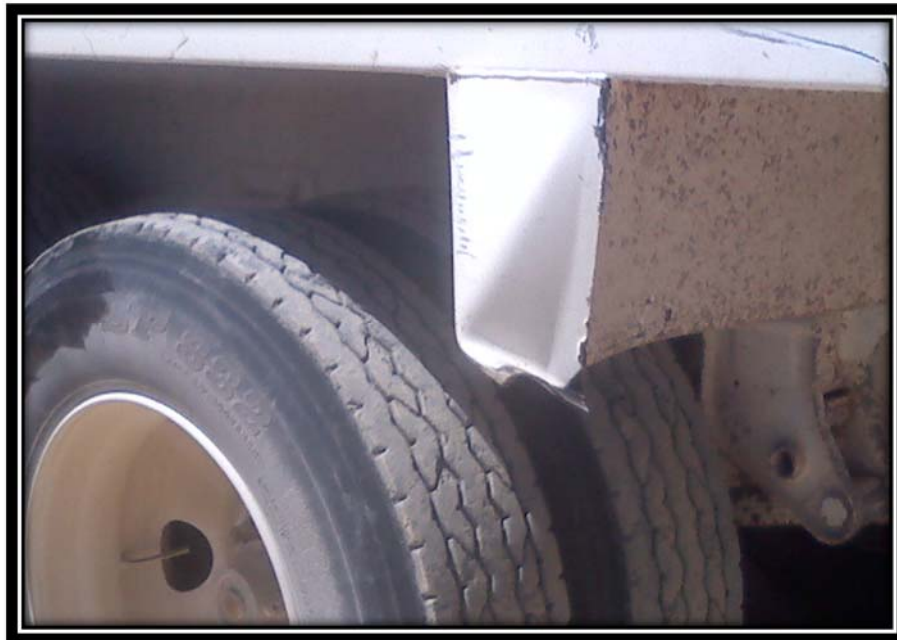
The height of the lower edge of the trailer for the water loaded tractor-trailer was approximately 48 inches above the ground. The lower edge of the end surface of the lateral support beam was approximately 30 inches above the ground. Minor black scrape marks were evident along the upper portion of the rear edge of the support beam. As described in the original report, minor buckling and bending of the right side of the lateral support beam was also evident. The previously supplied photograph indicates that this bending and buckling was directed forward and outward from the trailer (see Figure 1 for photograph of damage to the water loaded tractor-trailer).

Figure 1: Photograph of damage to the lateral support member on the water loaded tractor-trailer

The upper height of the fender on the cement loaded tractor-trailer was approximately 46 inches above the ground. This height indicates that the trailer bed on the water loaded tractor-trailer would not contact the fender on the cement loaded tractor-trailer. Instead, only the end surface of the lateral support beam on the water loaded tractor-trailer would contact the fender on the cement loaded tractor-trailer. Based on the heights of the damages, orientation of the vehicles and direction of travel of the water loaded tractor-trailer at the time of the impact, the scrape marks at the rear edge of the support beam appear to be related to the impact between the water loaded tractor-trailer and the cement loaded tractor-trailer.

However, as described in the original report, the bending and buckling of the right side of the support beam is not related to the impact between the two vehicles. The bending and buckling of the support beam is from a forward directed force that was concentrated along the lower edge of the support beam. Based on the height of the damage, this damage is consistent with the water loaded tractor-trailer or cement loaded tractor-trailer reversing after the impact in an attempt to separate the two vehicles. As the vehicles would reverse, the lower edge of the support beam on the water loaded tractor-trailer would contact the tire on the cement loaded tractor-trailer. This contact would result in a concentrated forward directed force on the lower edge of the support beam consistent with the damage evident in the photograph.

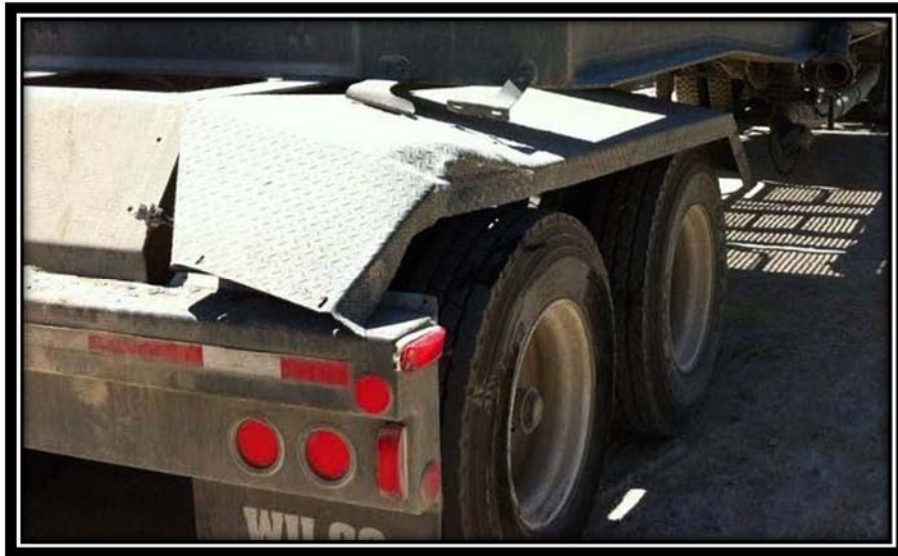
Also, as described in the original report, minor damage was evident to the right fender located at the rear of the trailer for the cement loaded tractor-trailer. This damage consisted of a minor indentation in the side of the fender towards the rear. In addition, several of the support bolts were pulled through the fender and the mounting brackets were bent. From the additional supplied photograph it can be seen that two of the rear bolts were pulled through along with two bolts for the right support bracket (see Figure 2 for photograph of damage to the right fender).

Figure 2: Photograph of damage to right fender of cement loaded tractor-trailer

Based on this new photograph, an additional analysis was performed to determine the force required to result in the damage to the right fender. This analysis was based on the bolt pull through evident on the right fender.

Stress calculations indicate that the maximum force that would be exerted would be between 12 – 36 kips¹. These forces would result in average accelerations of 0.1 – 0.2 G. These forces are slightly lower than predicted using the method described in the original report. Calculations detailed in the original report indicate that average acceleration were on the order of 0.3 – 0.5 G. This difference in calculations is due to the conservative calculations performed in the original report based on the more limited photographs. These calculations further confirm the relatively low forces and minor accelerations that were imparted during this impact.
